Activity: Supplementary Risk Assessment for Swanage Beach north of Ocean Bay following landslides and rock falls

Risk Assessment Completed By: Michael Gould and Matt Smith

Date: January 2019

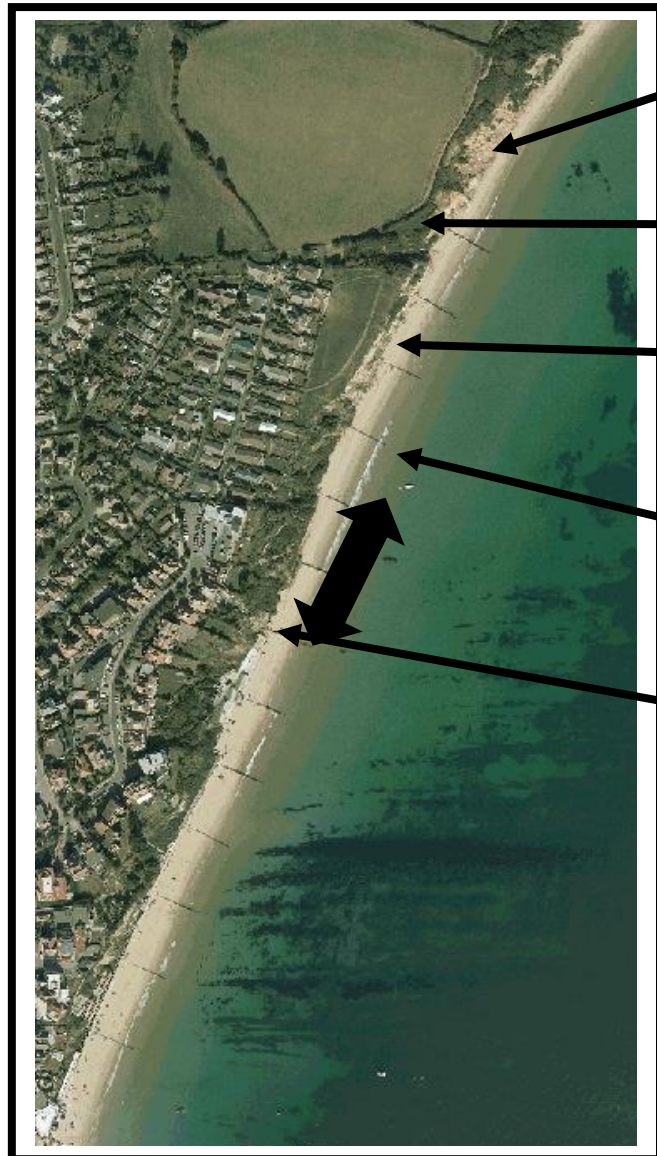
The aerial photograph and annotations below details the risk assessment

Lots of loose material at the tops of the cliffs – keep clear of the base of cliffs – be aware of areas of freshly fallen angular material and also mudflows

Footpath to Sheps Hollow has been badly eroded and present a trip and skip hazard in places. Ensure that all students and staff are fully briefed on taking care and helping each other down the stairs.

Big rockfall from the expanse of clean sandstone mid way between groynes – keep clear of the cliff base along the whole of this section

MAJOR mudflow at this point – there is no safe way of avoiding this so approach carefully and ensure low tide to be able to maneuver over groyne.

Lots of landslide debris above the multistorey beach huts and also a crack developing in the “wall” above the stonebuilt huts at the end of the promenade. DO NOT approach / try to climb over the groyne immediately north of the where the footpath down Burlington Chine (by the Grand Hotel) meets the promenade – NO access to the beach beyond this point.

Only use the beach at low tide or at times close to low tide – to ensure that enough beach is available so that a group can give sufficient space between them and the base of the cliffs.
